**UPPER PATUXENT RIVER WATERSHED RESTORATION ACTION STRATEGY (WRAS)
FORM 1 -- Catchment Information**

**UPPER PATUXENT RIVER WATERSHED RESTORATION ACTION STRATEGY (WRAS)
FORM 2 -- Site Information**

Site Name: Federal Express Address: Baldwin Avenue, Crofton, MD

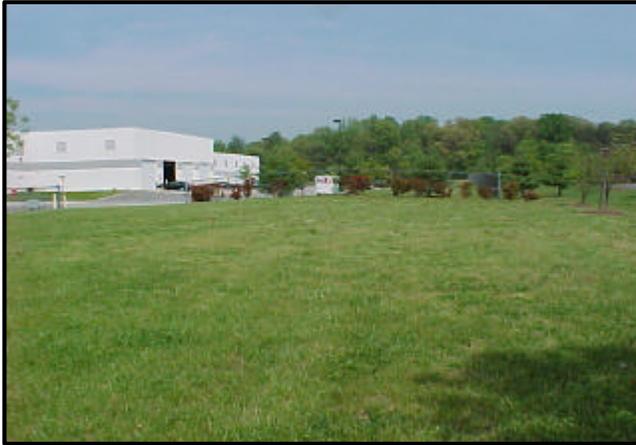
- No. 695 Description: looking east along south side of property
- No. 696 Description: looking north along west side of property
- No. 697 Description: looking south along west side of property
- No. 698 Description: looking east along north side of property
- No. 699 Description: looking south along east side of site
- No. 700 Description: looking west along north side of site
- No. 701 Description: looking west along south side of site
- No. 702 Description: looking north along east side of site
- No. _____ Description: _____
- No. _____ Description: _____

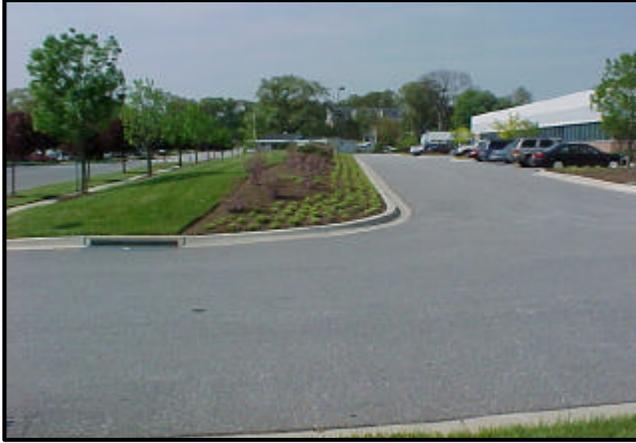
705

No.	<u>705</u>	Description:	<u>looking north</u>
No.	<u>706</u>	Description:	<u>looking south</u>
No.	_____	Description:	_____
No.	_____	Description:	_____
No.	_____	Description:	_____
No.	_____	Description:	_____
No.	_____	Description:	_____
No.	_____	Description:	_____

Comments Due to high volume of FEDEX vehicle travel, directing flow using raised bituminous "speed bumps" is not recommended. Use trench drains and curb cuts.
